Manhole Inspection Summary

Manhole # S41C__010MH

Insp Date: **7/24/08 11:57 AM**

Location Address: **1439 N Caroline ST**

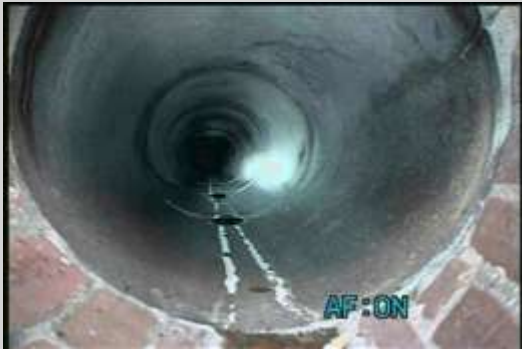
12 O'Clock Outflow

15 in. Circular Gravity Sewer
Pipe Out @ 12 O'Clock

Invert Depth: 6.75 (ft.) Flow Characteristics: None

Infiltration: None Pipe Seal Cond: Unknown

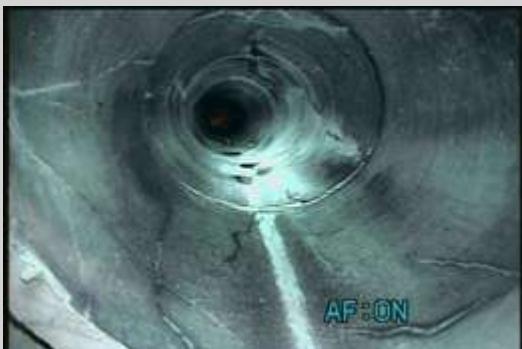
8 O'Clock Inflow

15 in. Circular Gravity Sewer
Pipe In @ 8 O'Clock

Invert Depth: 4.75 (ft.) Flow Characteristics: None

Infiltration: None Pipe Seal Cond: Unknown

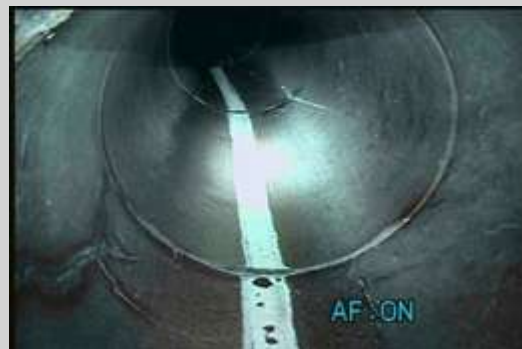
Drop In @ 8 O'Clock

Drop: Outside Direct

Drop Condition: Open
